PHASE I INSPECTION REPORT  
NATIONAL DAM SAFETY PROGRAM

**CATARACT CREEK DAM  
PONY, MONTANA  
MADISON COUNTY  
MT-5**

PREPARED BY:  
CH2M HILL  
BELLEVUE, WASHINGTON

APRIL 1980

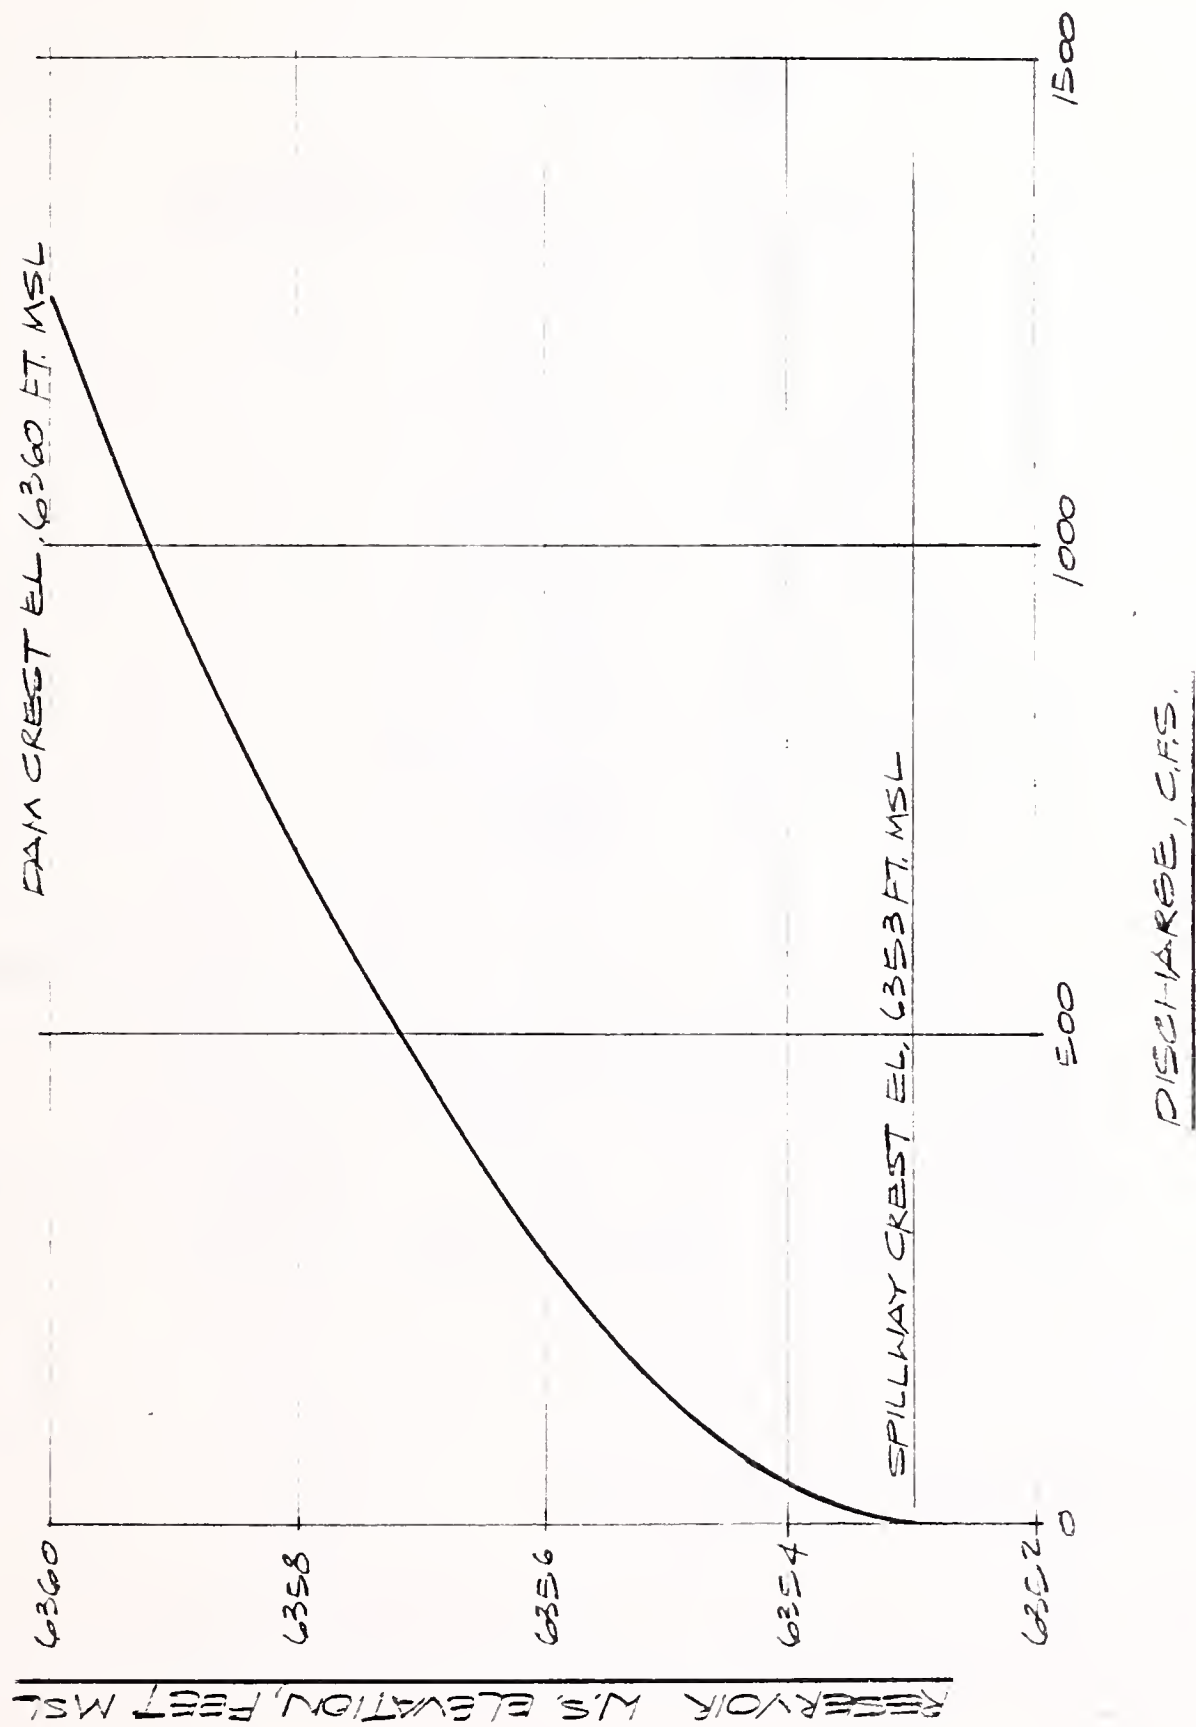
**PLATE 5**  
**CATARACT CREEK DAM**  
**SPILLWAY RATING CURVE**

The discharge rating for the spillway was developed by assuming that critical depth occurs at the concrete spillway crest. Backwater effects were computed for the approach channel with a Manning's "n" of 0.025. The maximum discharge capacity of the spillway with the reservoir at the top of the dam, elevation 6360 feet NGVD, was estimated to be 1,250 c.f.s. The spillway rating curve is presented on Plate 5.

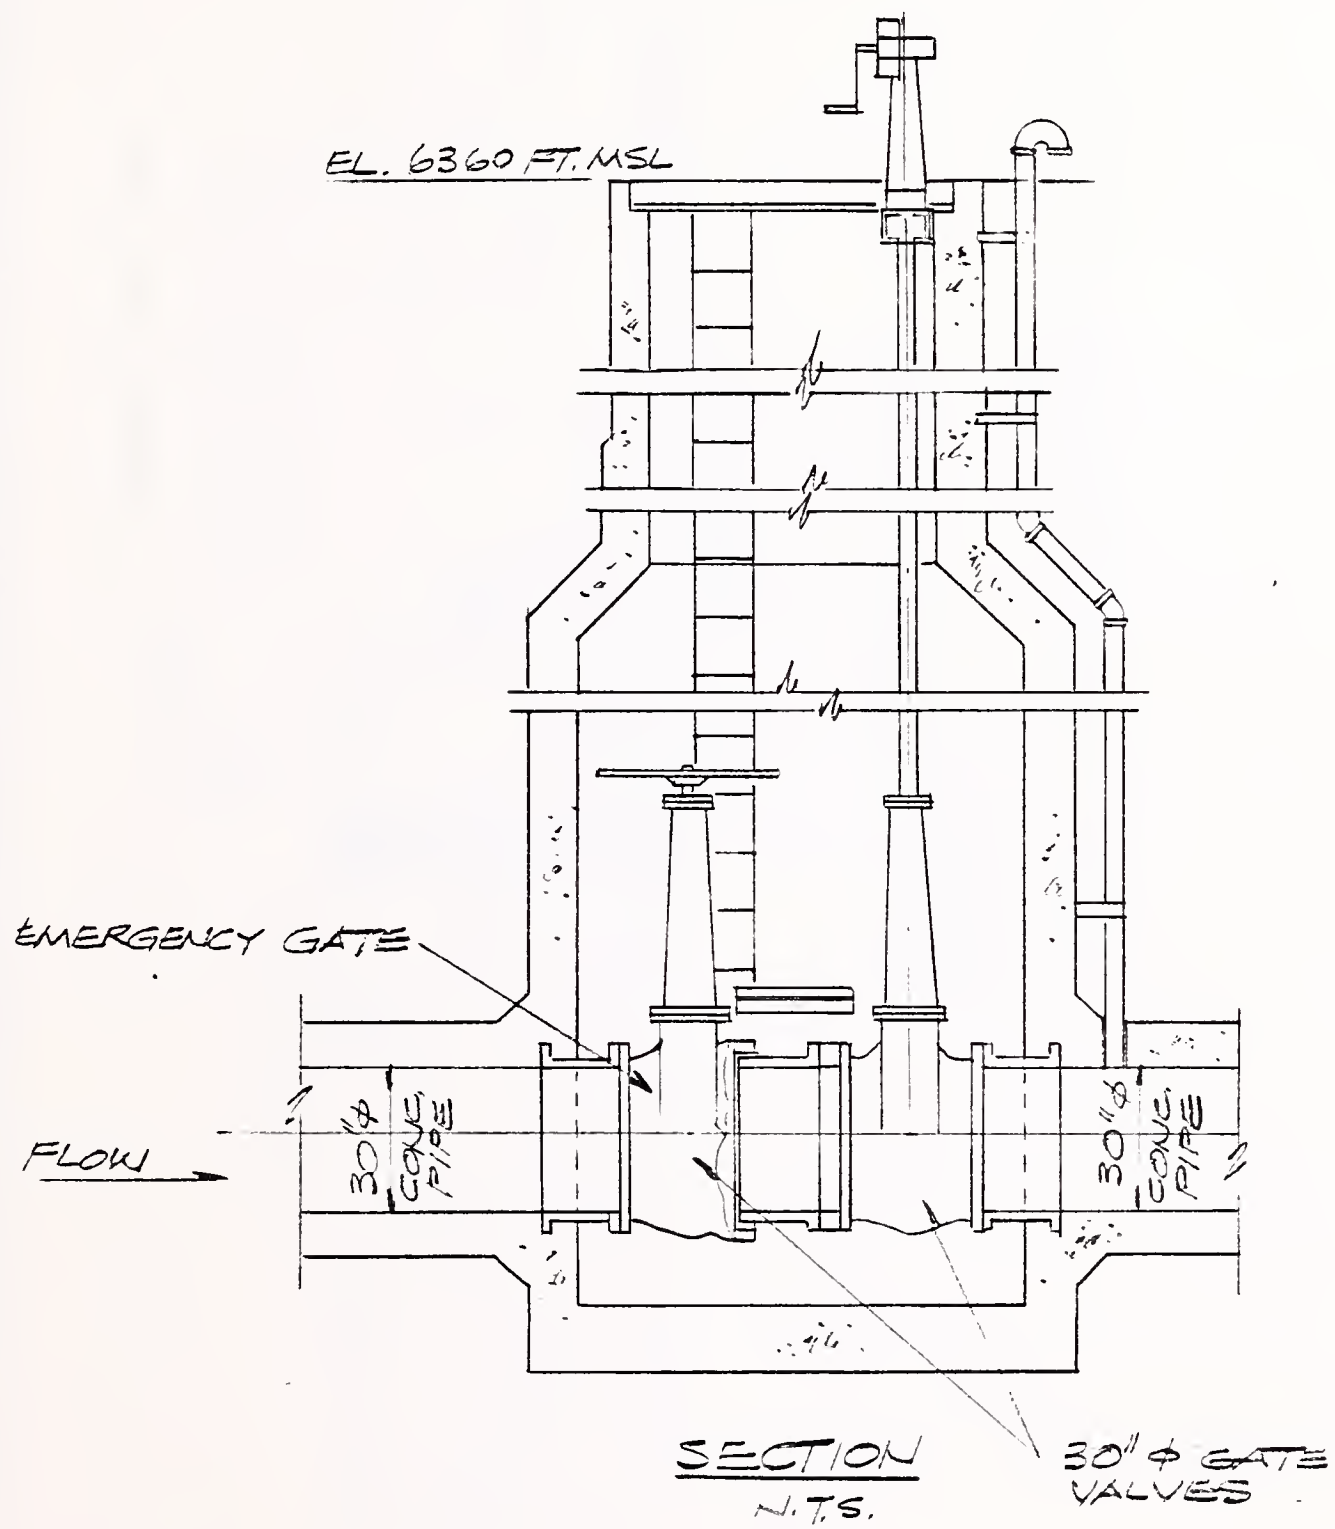
PLATE 6

The control for the 30-inch-diameter emergency gate valve is located at the bottom of the tower. The control for the 30-inch-diameter operating gate valve is located at the top of the tower near the crest of the dam and appeared to be in good condition (see Photo 5). The control handle is locked to the control housing. A wooden deck on the top of the gate tower is bolted down to prevent easy access to the tower.
